**KOMITE NASIONAL KESELAMATAN TRANSPORTASI  
REPUBLIC OF INDONESIA**

# **PRELIMINARY**

**Aircraft Accident Investigation Report**

**Boeing 737-500; PK-CLC**

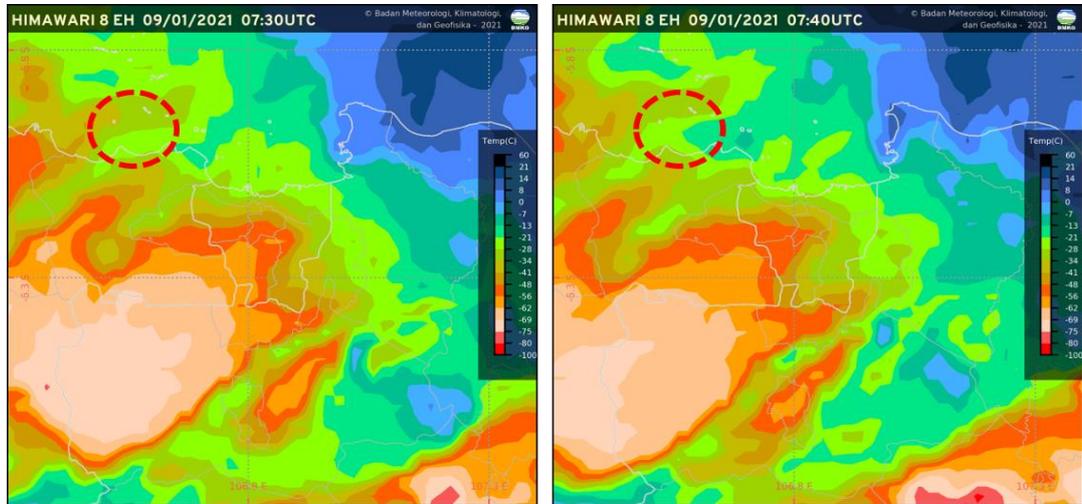
**Figure 1: Enhanced infrared satellite image at 0730 UTC and 0740 UTC at accident site (red-dotted circle)**

The *Badan Meteorologi Klimatologi dan Geofisika* (BMKG – Bureau of Meteorology, Climatology and Geophysics) provided enhanced infrared satellite images. The enhanced infrared satellite images at 0730 UTC (1430 LT) and 0740 UTC (1440 LT) indicated that the cloud top temperature at the accident site (red circle) was from  $-34^{\circ}\text{C}$  to  $-21^{\circ}\text{C}$ .

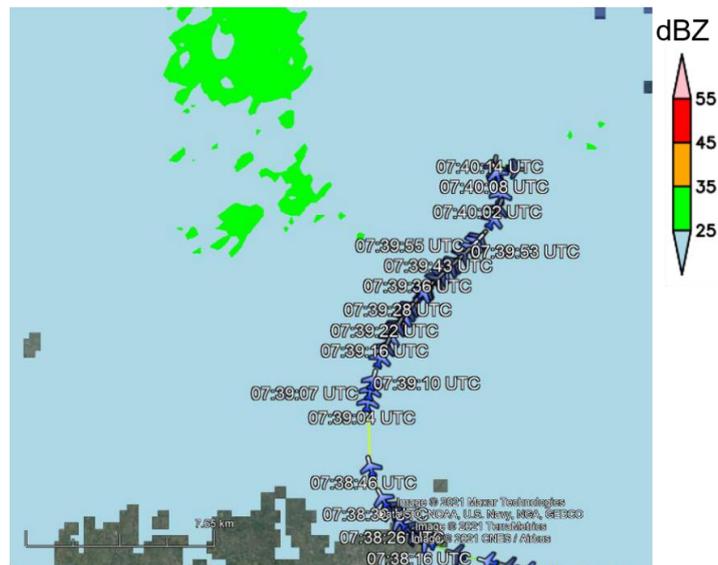
**Figure 2: The superimposed ADS-B-based flight profile with BMKG radar weather image at 1438 LT**

The superimposed ADS-B-based flight profile with radar weather image at 1438 LT provided by the BMKG indicated that the radar intensity level along the flight profile was not more than 25 dBZ<sup>9</sup>, which means that the flight path did not indicate any significant development of clouds.

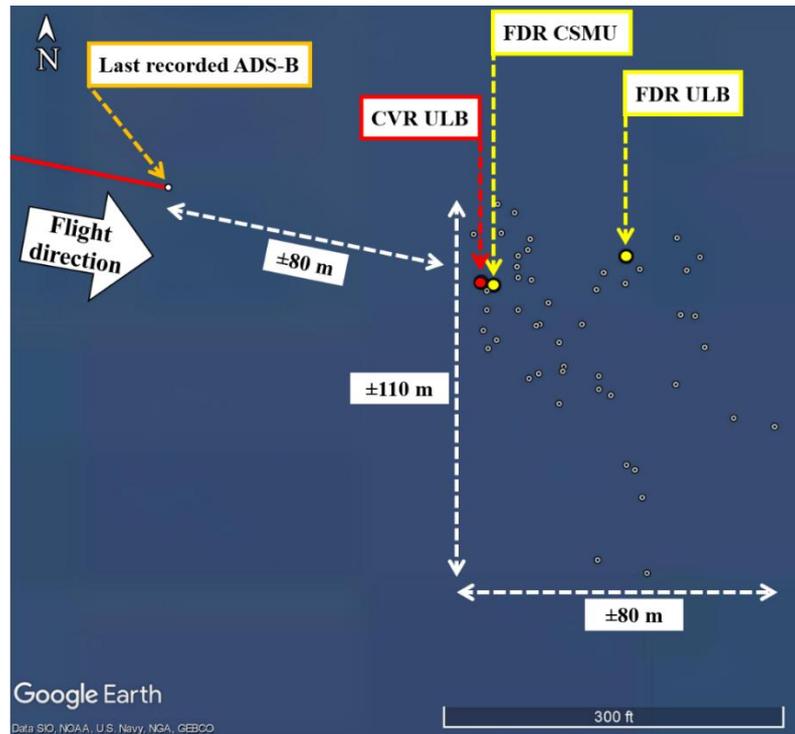
**Figure 4: Location of FDR CSMU, FDR ULB and CVR ULB relative to the last ADS-B recorded data**

The search team identified that the wreckage was about 80 meters south east from the last known aircraft position recorded by the ADS-B. The wreckage was distributed across an area of about 80 by 110 meters on the seabed at a depth of approximately 16 meters.

The FDR's CSMU was found within the wreckage distribution area at coordinate 5°57'51.00" S 106°34'31.00" E. The ULBs were detached from both the FDR and the CVR<sup>10</sup>. The FDR's ULB was found at coordinate 5°57'50.76" S 106°34'32.10" E approximately 35 meters from the FDR's CSMU, and the CVR's ULB was found at coordinate 5°57'50.98" S 106°34'30.90" E.
